Damages on Unreinforced Masonry Buildings in Kathmandu Valley After Gorkha Earthquake 2015

Dr. Rajan Suwal

ABSTRACT : Unreinforced masonry buildings are ubiquitous in Nepal due to the use of locally available materials, straightforward building techniques and economic viability. However, the Gorkha Earthquake 2015 affected these masonry buildings the most. This paper assembles the information collected during the reconnaissance of the unreinforced masonry buildings after the earthquake in Kathmandu Valley. It highlights the damages caused by Gorkha Earthquake 2015 in the unreinforced masonry buildings in Kathmandu Valley and attempts to identify the possible causes of the damages. This paper also presents some recommendations for the construction of unreinforced masonry buildings so that such catastrophic devastation can be avoided in the future.

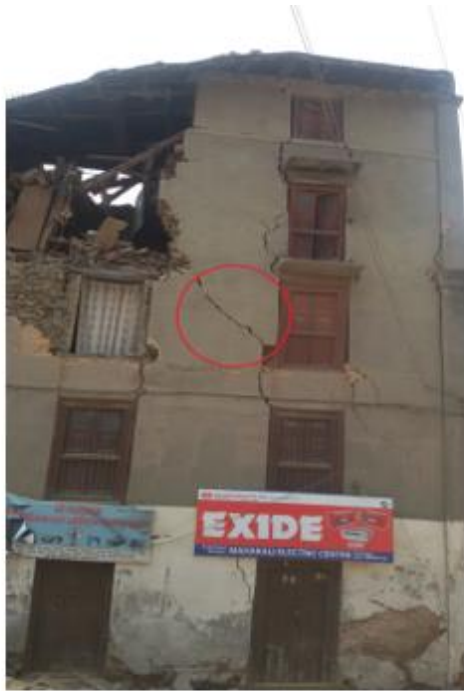
V.1.Diagonal Cracks: Diagonal cracks due to an earthquake in buildings basically occur when the tensile stresses developed due to the vertical loads and horizontal seismic load exceed the tensile strength of the masonry material i.e. weak unreinforced masonry is one of the causes of diagonal cracks. Moreover, the diagonal cracks are normally inclined at 45 degrees to the horizontal plane, but depending on the magnitude of the horizontal loads and vertical loads, the inclination might differ [Bayulke N, 1978]. This category of crack is among the most common types of cracks that were observed after the earthquake. In case of the traditional buildings in Kathmandu Valley, the buildings suffered from diagonal cracks due the absence of horizontal bands (floor bands, lintel and sill bands). The diagonal cracks observed passed through the mortar rather than bricks, from which we can infer that the mortar used, were weaker than the bricks. The diagonal cracks can be well observed in fig 1.a and 1.b.

Fig. 1.a: Diagonal shear crack

1. Diagonal cracks have been observed in most of the buildings due to the absence of floor bands, lintel bands and sill bands and also due to the weak mortar. It is recommended to use such horizontal timber bands in traditional building to avoid diagonal cracks in the future.

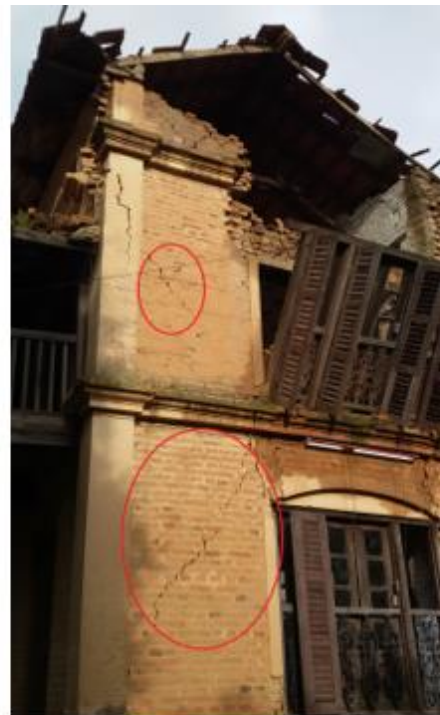
Fig. 1.b: Diagonal shear crack

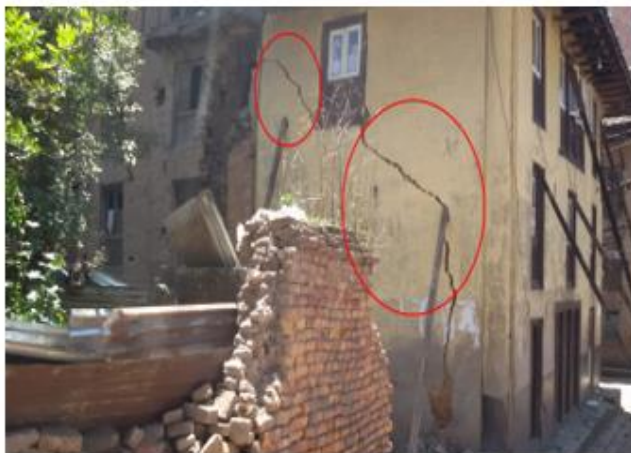
Furthermore, as seen fig 1.c and 1.d, the diagonal cracks mostly emanated from the corners of the openings, since the corners are the points of stress concentration.

Fig. 1.c: Diagonal shear crack

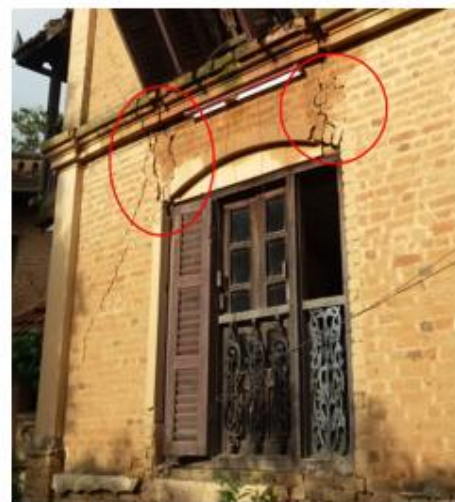
Fig. 1.d: Vertical shear crack

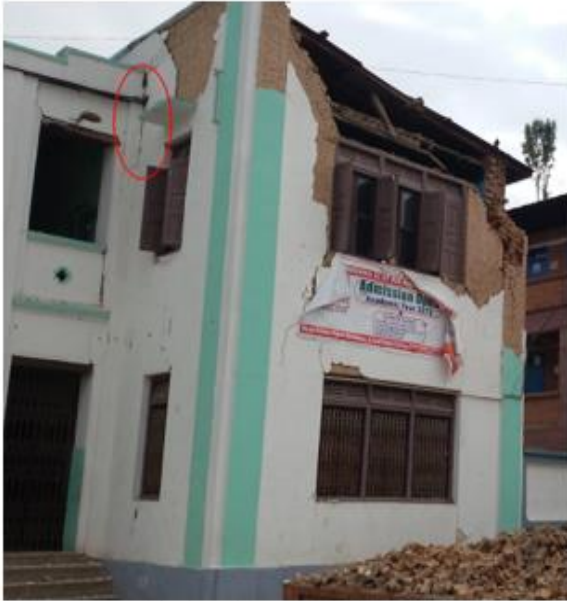
V.2. Corner Failure: Corner cracks occur as a result of stress concentration at the corners. In the traditional masonry buildings in Kathmandu Valley, the slabs used were basically made up of timber, which are not rigid enough to hold the adjacent walls together. As a result of this, during earthquake, the walls tend to separate at the corners resulting in corner cracks. As shown in fig. 2.a and fig. 2.b, we can see the corner cracks as indicated, which might have occurred due to the irregularity in the plan of the building and accumulation of stress at the

Fig. 2.a: Corner Crack

2. The lack of connection in between the perpendicular walls has triggered the corner failure and vertical cracks too. In addition to this, the irregularity in the plan of the buildings has caused stress accumulation around the corners hence exacerbating the situation. It is, thus, suggested to connect the perpendicular walls sufficiently and also separate an irregular building into regular blocks by creating some gap in between.

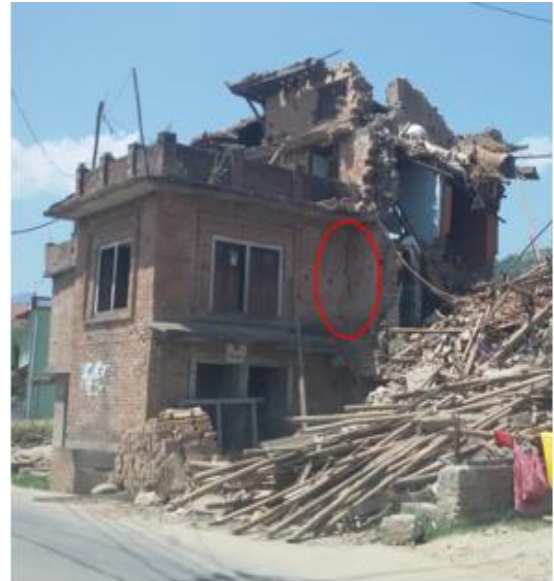
Fig. 2.b: Corner crack

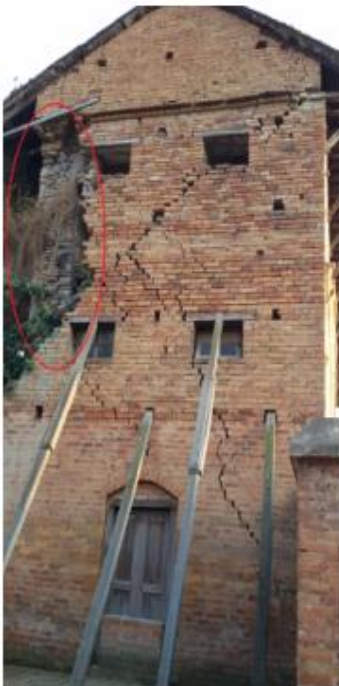
corners. Also, due to the irregularity in the plan of the buildings, the regular bays might have moved as separate units, hence causing the cracks to appear at the corners. The corner failure as seen in fig. 2.c and 2.d is due to the lack of connection in between the two perpendicular walls. The failure could have been prevented if the two walls were constructed integrally or if corner ties were provided.

Fig. 2.c: Corner failure

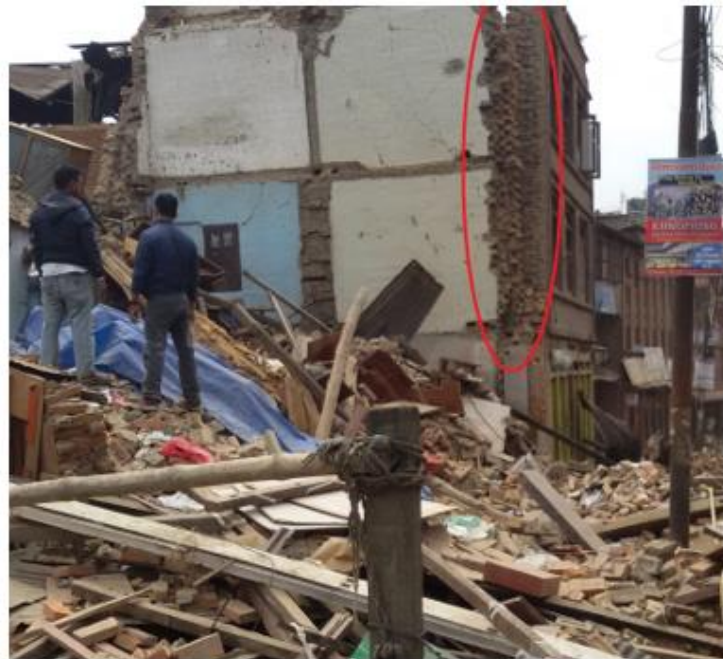
Fig. 2d: Corner failure

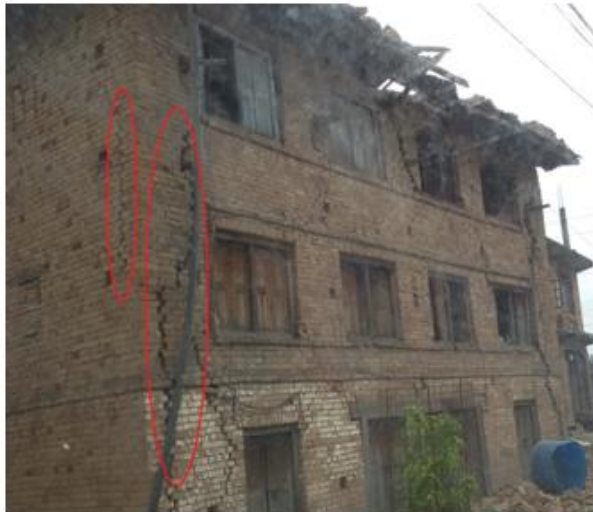
Fig. 3.a: Vertical crack

As in fig. 3.a we can observe vertical cracks in the directions of both in plane and out of plane failure. A number of diagonal cracks can also be seen in the building which implies that the initial shaking of the earthquake caused the diagonal cracks, and then, as the trembling intensified, the vertical load carrying capacity of the building lowered and vertical cracks might have appeared and slowly propagated. Similarly, vertical cracks can be seen in fig. 3.b. These cracks in the adjacent walls might have appeared due to the increase in tensile stresses in the walls

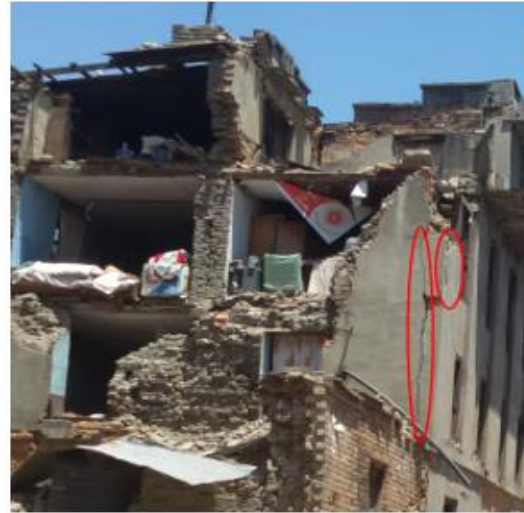
Fig. 3.b: Vertical crack

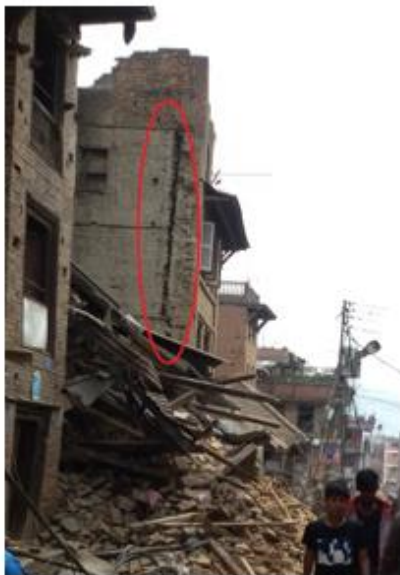
Fig. 3.c: Vertical crack at corner

due to out of plane failure. Moreover, the lack of anchorage at the corners must have been the cause of the vertical cracks as shown in fig. 3.c and fig. 3.d.

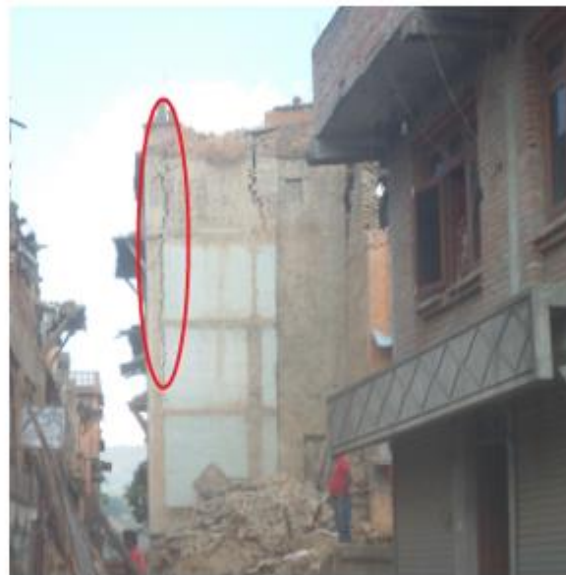
Fig. 3.d: Vertical crack at corner

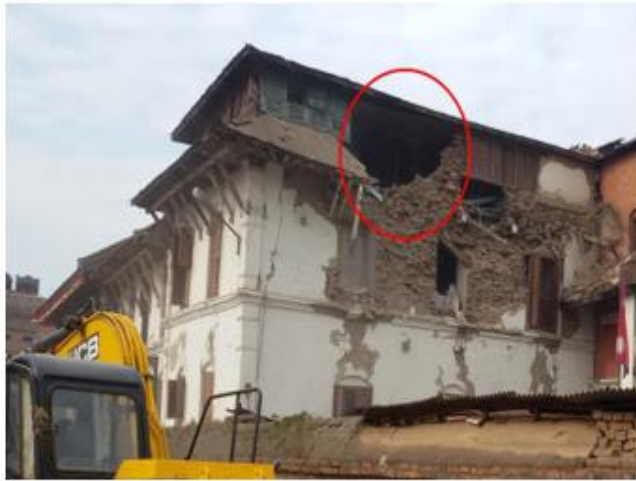
V.4. Out of Plane Failure: This kind of failure occurs in a wall when the direction of earthquake load is perpendicular to the wall and the wall is not sufficiently anchored to the adjacent walls, floors or the roof, such that it decreases the possibility of prevention of failure. Fig. 4.a and 4.b show an out of plane failure. Here, the possible cause is the lack of anchorage with the roof at the top of the wall due to which the wall was unsupported at the upper end and since the inertia force is higher, the wall clearly couldn't resist the lateral earthquake load. In addition to this, the first floor of the building as shown in fig. 4.b might have suffered from out of plane failure due to the lack of rigid diaphragm to act as a rigid support of wooden columns.

Fig. 4.a: Out of plane failure of top floor

3. Lack of rigid diaphragm, lack of enough anchorage with the cross walls and undesirably long unsupported length of walls have been found to be the causes of out of plane failure. To avoid this failure in the future, rigid diaphragm are to be used, cross walls are to be placed to support the whole length of the walls and properly anchored to them.

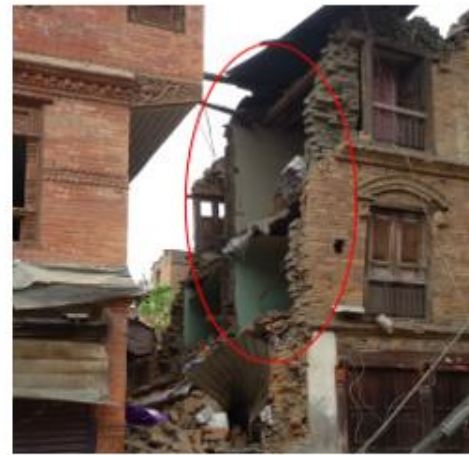
Fig. 4.b: Out of plane failure

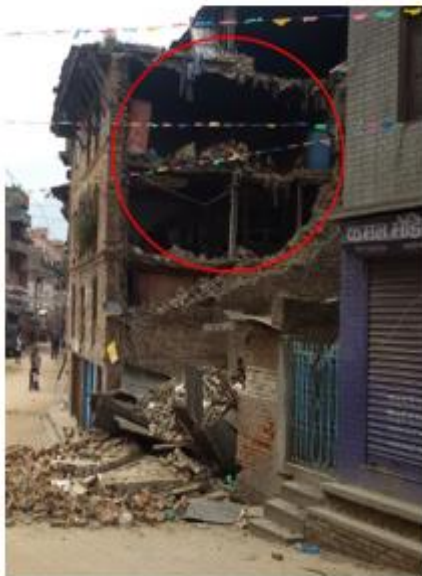
Fig. 4.c: Out of plane failure

Similarly, the out of plane failure as seen in fig. 4.c might have been due to the absence of cross wall over the length of the overturned wall. The wall must have failed due to its inability to resist the earthquake force during seismic activity in lateral direction. Moreover, the failure of the building in 4.d might have occurred due to the lack of proper connection to the cross wall on one side and to the timber column and floors at the other side. Along with it, even the flexible diaphragm might have aggravated the out of plane failure.

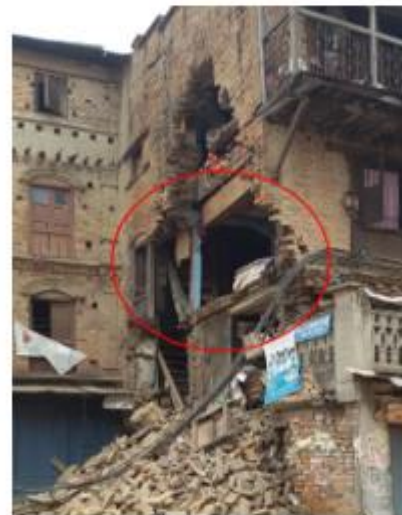
Fig. 4.d: Out of plane failure in lower stories

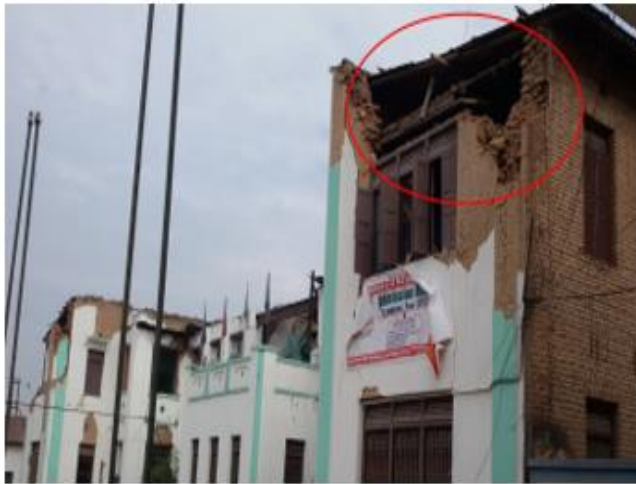
Fig. 5.a: Top roof wall failure

Fig. 5.a and fig, 5.c show the failure of top roof wall. Fig. 5.b and fig 5.d show gable wall failure. We can clearly observe the timber frames that have been apparently used as frame of the gable. Gable bands of timber or other material are absent in both of these buildings due to which during the earthquake, the walls failed as a result of higher inadequate restraints and inertia force.

4. Lack of gable band has been found to be the main cause of gable wall failure. Thus, gable bands are a must to avoid such failure.
5. It has been concluded that the delamination of wythes have resulted due to the use of poor masonry and lack of bonding in between the bricks used. This can largely be avoided by the use of masonry of good quality and proper connection of different wythes of masonry wall.

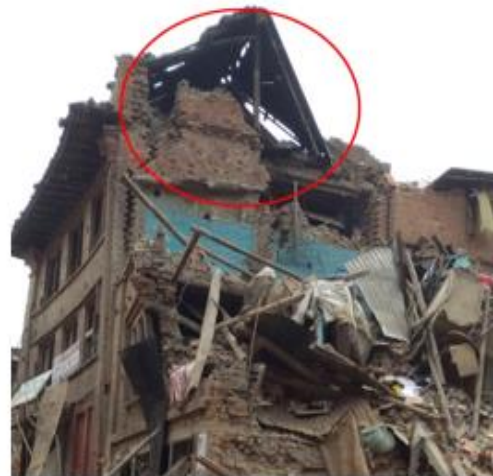
Fig. 5.b: Gable roof wall failure

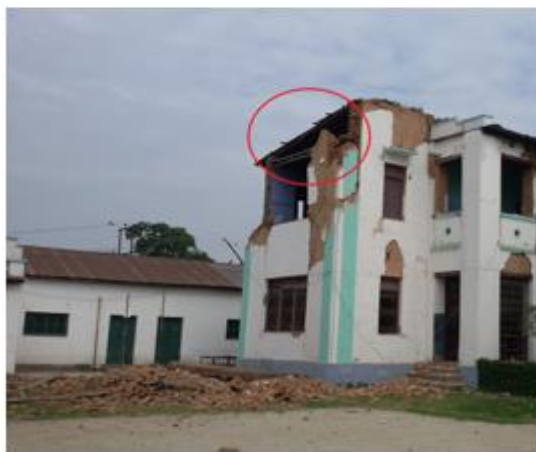
Fig. 5.c: Top roof wall failure

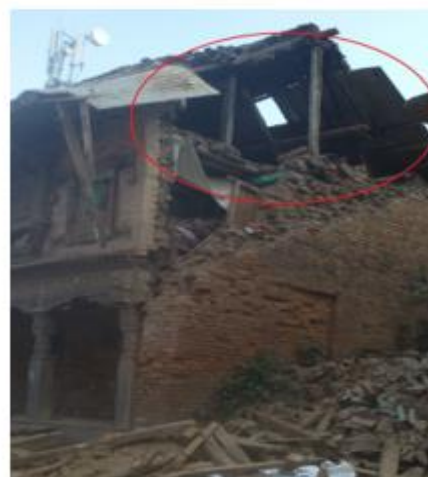
Fig. 5.d: Gable roof wall failure

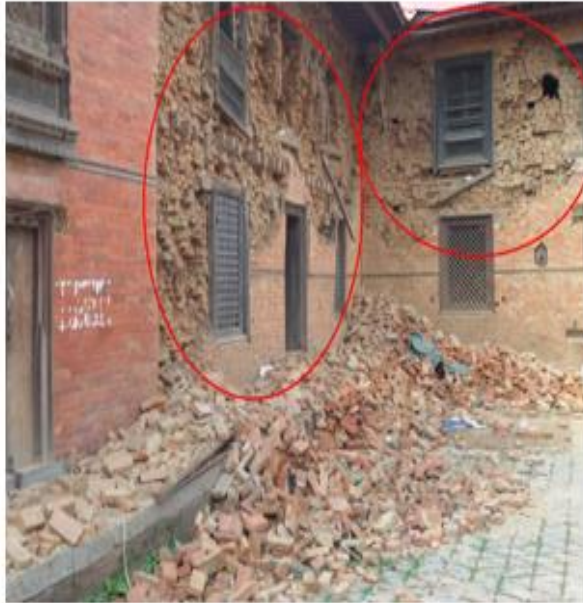
Fig. 6.a: Failure of outer layer of brick wall

Regarding the houses surveyed in Kathmandu Valley, the quality of mortar was found to be low. The delamination of wythes caused in fig. 6.a, fig 6.b, fig.6.c and fig. 6.d are also most likely due to improper bonding between different layers and due to low quality of mortar.

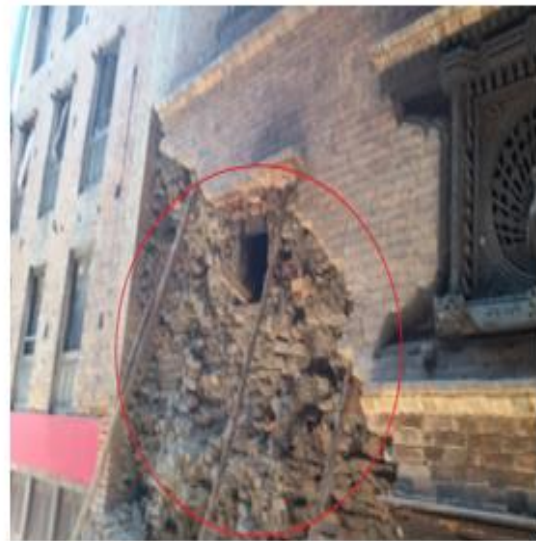
Fig. 6.b: Failure of outer layer of brick wall

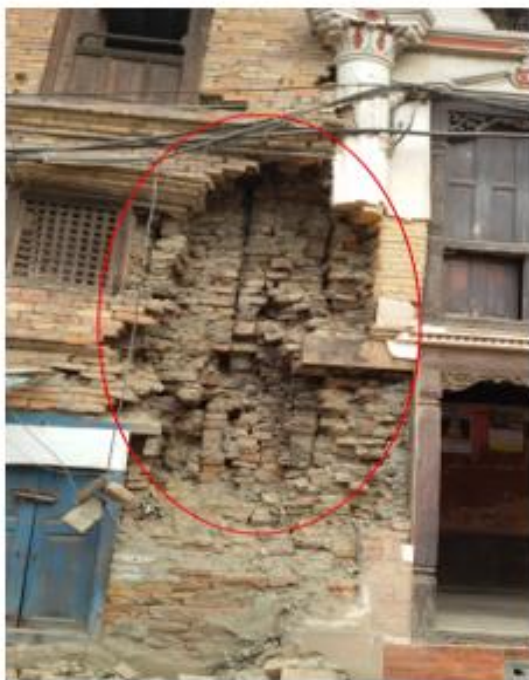
Fig. 6.c: Failure of outer layer of brick

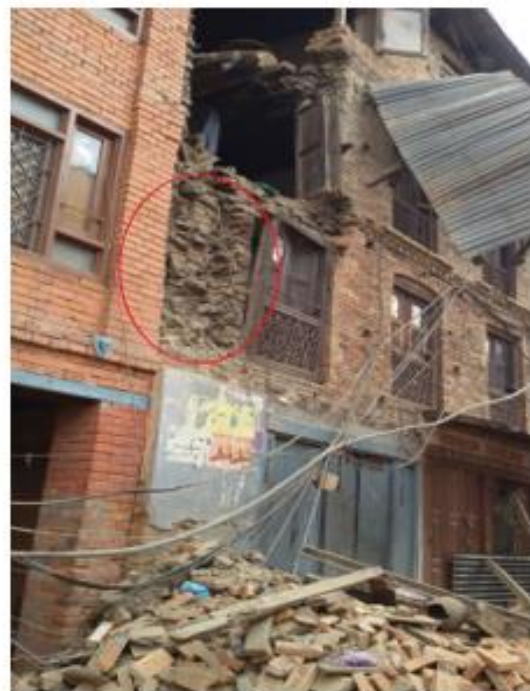
Fig. 6.d: Failure of outer layer of brick
