Insurance fraud or unusual damage to a vehicle?

ABSTRACT: *The article deals with the issue of insured events. It points out the fact that insurance companies suffer financial losses in the case of insurance frauds. Then the procedures of the insurance companies are explained and how the insurance companies work in order to determine whether in a specific case it is an insurance fraud or not. The unusual damage to a vehicle and the procedure by which the insurance company settled the damage are presented. The steps taken by the owner of a vehicle and a court that invited a technical expert have been clarified. Next, the description of the technical expert's working procedures and the results of his investigation are showed.*

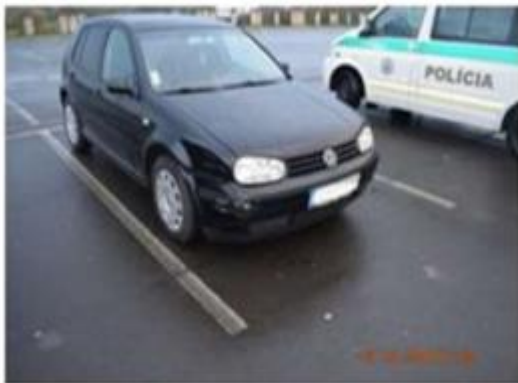
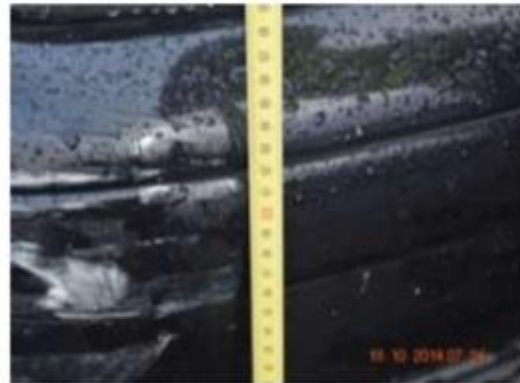
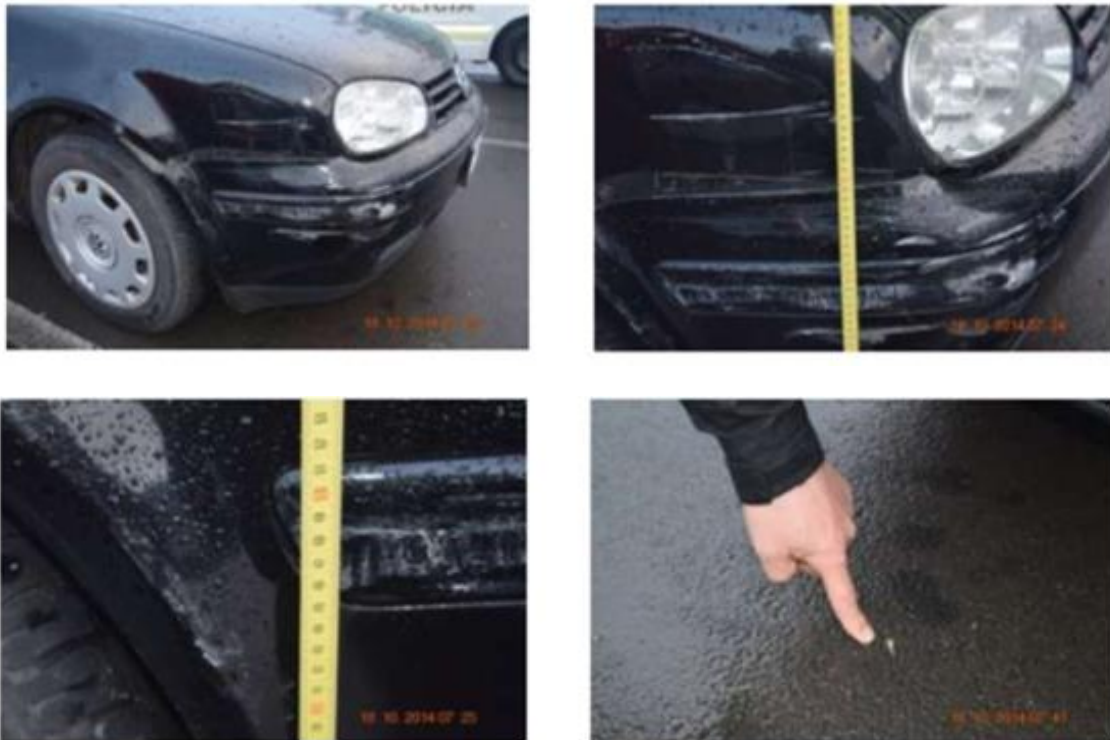
Fig.1 Police photographic documentation – damaged VW Golf

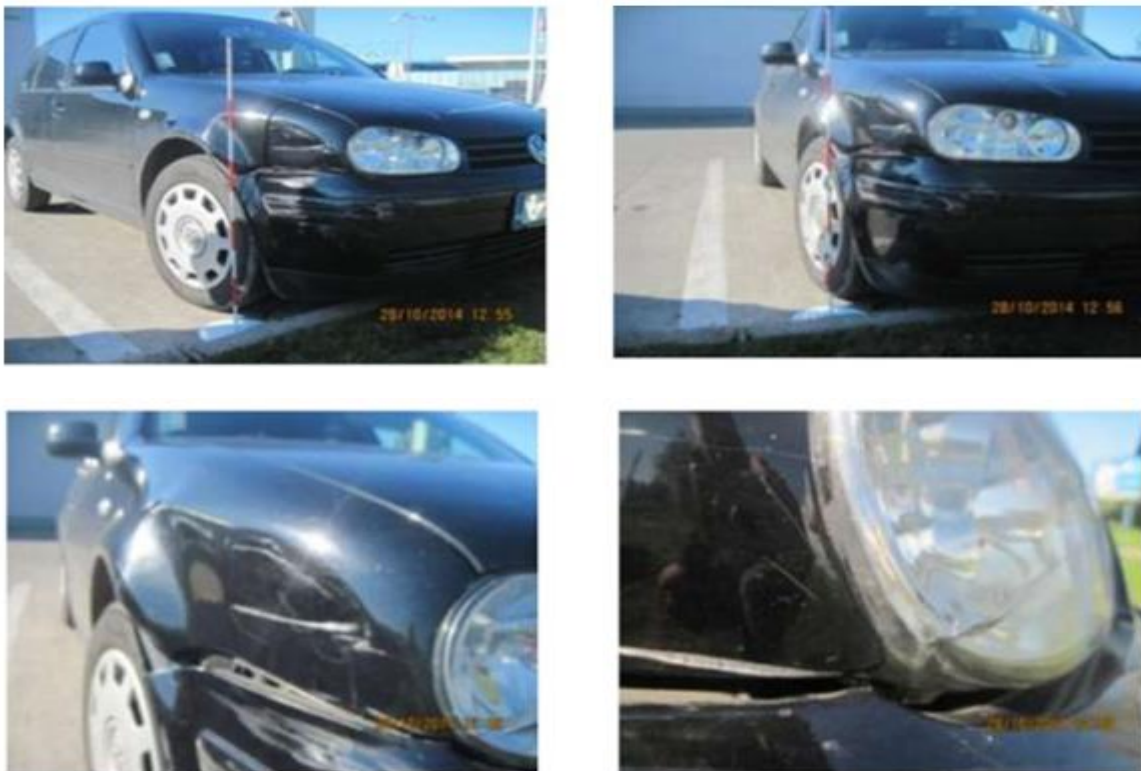
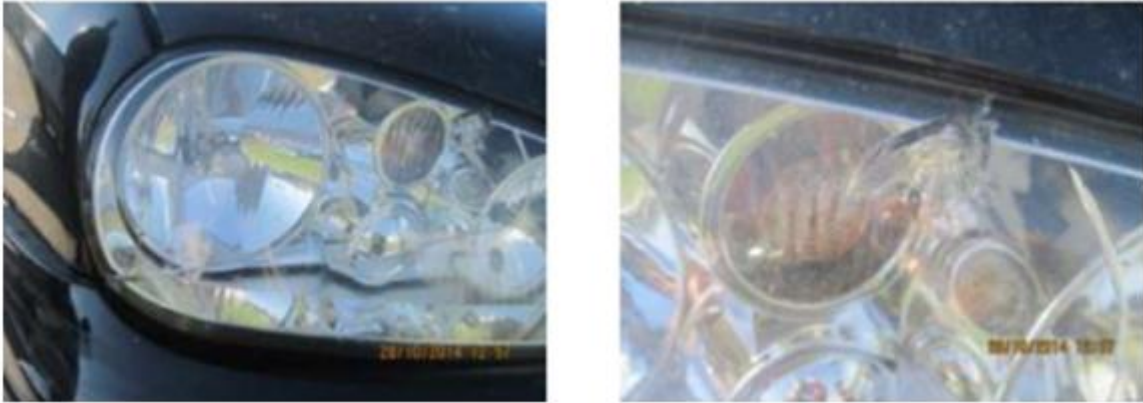
Fig.2 The photographs of the damaged VW Golf taken by the insurance company

Conclusion of the insurance company analysis: The insurance company's employees compared the height of the rear bumper of the Honda Accord, which was 0.5 m and the height of the front right fender deformation of the VW Golf, which was 0.7 m suggesting that the rear bumper of the Honda could not cause the deformation of the Golf and that the damage in question had to be done to the Golf before the time it was allegedly damaged. Based on this, the insurance company refused to repay the repair costs to the owner of the Golf.

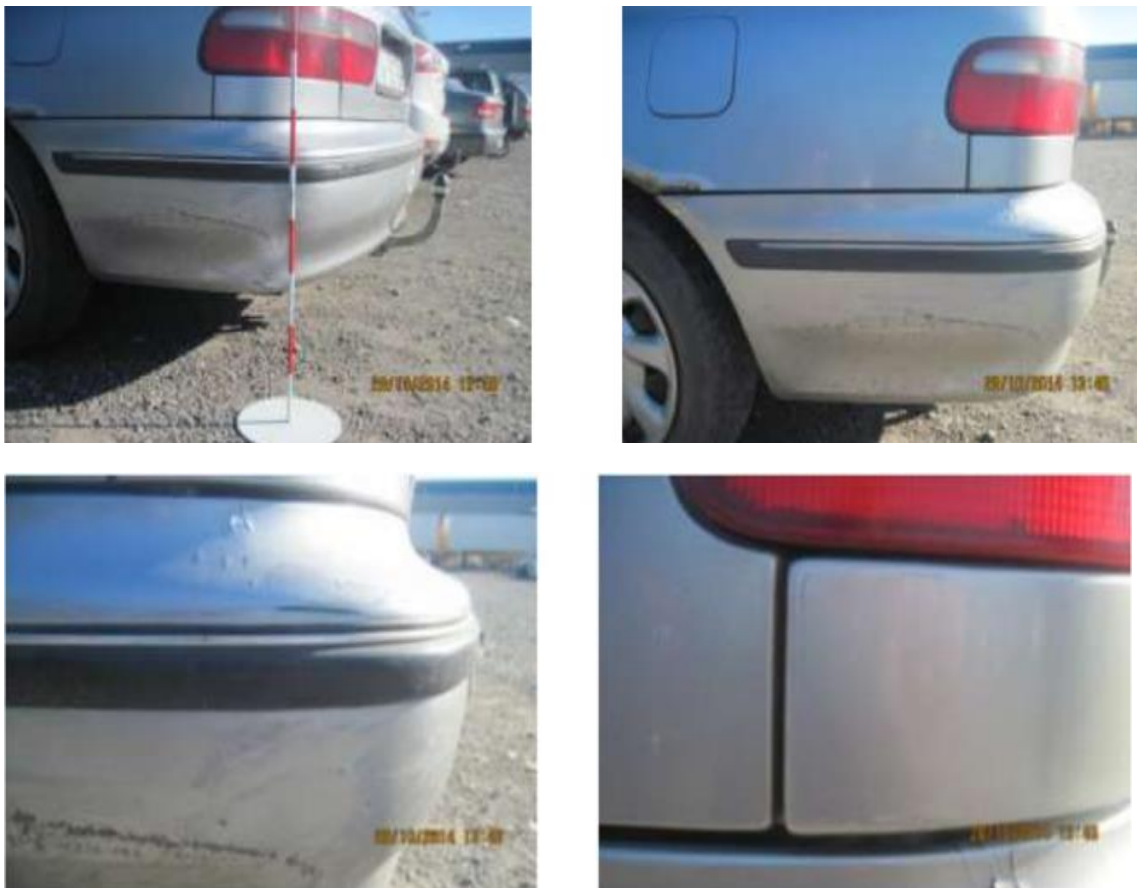
Fig.3 Photographs of the damaged Honda Accord taken by the insurance company

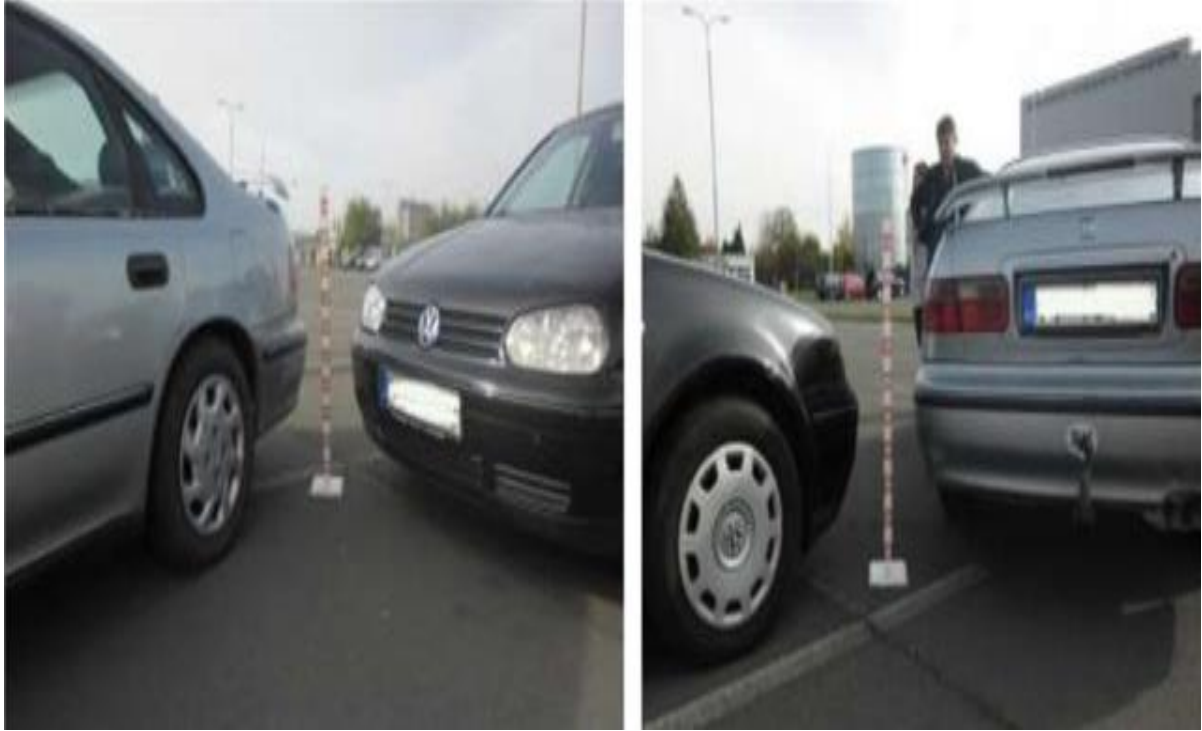
Fig.4 Photographs taken by the technical expert while measuring the positions of both vehicles on the spot
The vehicles positions plan view before the VW Golf was damaged Fig.5.

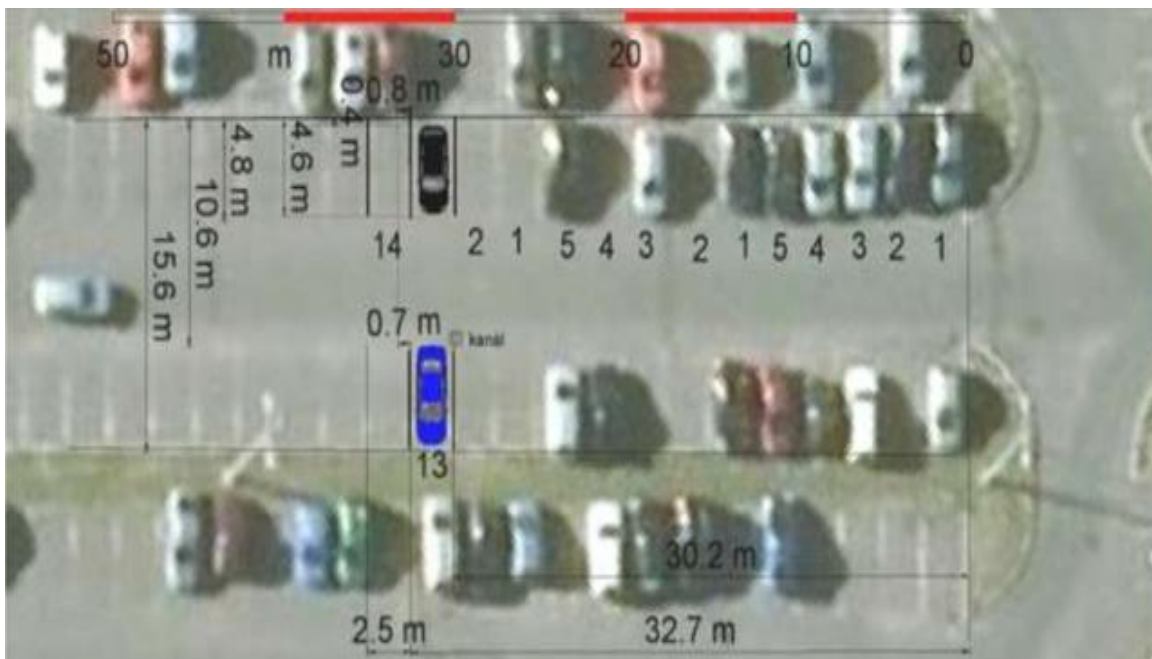
Fig.5 Mutual Position of Vehicles

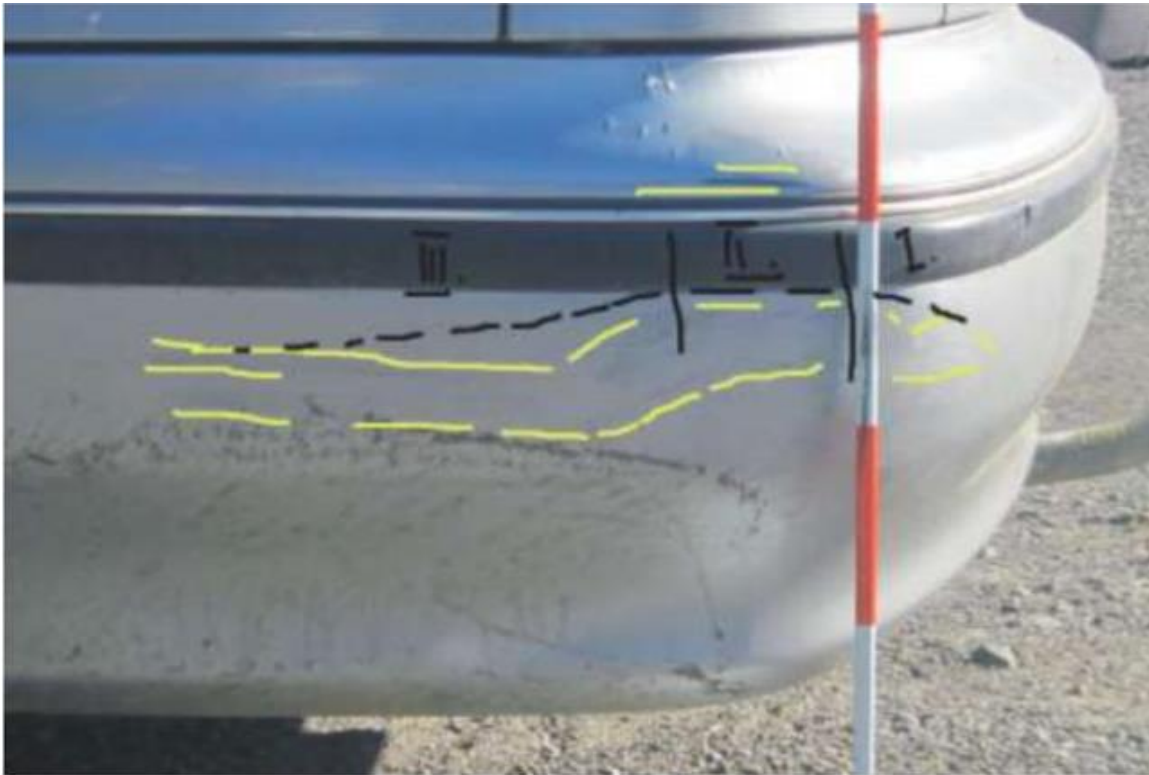
Damage to the Honda Accord: Rear bumper left side Abrasions on the bumper are marked in yellow the change in contact surface heights of the vehicle due to dynamic effects (Section I - acceleration, Section II - decrease in acceleration, Section III - braking) Fig.6, Fig.7

Fig.6 display of Honda Accord bumper damage

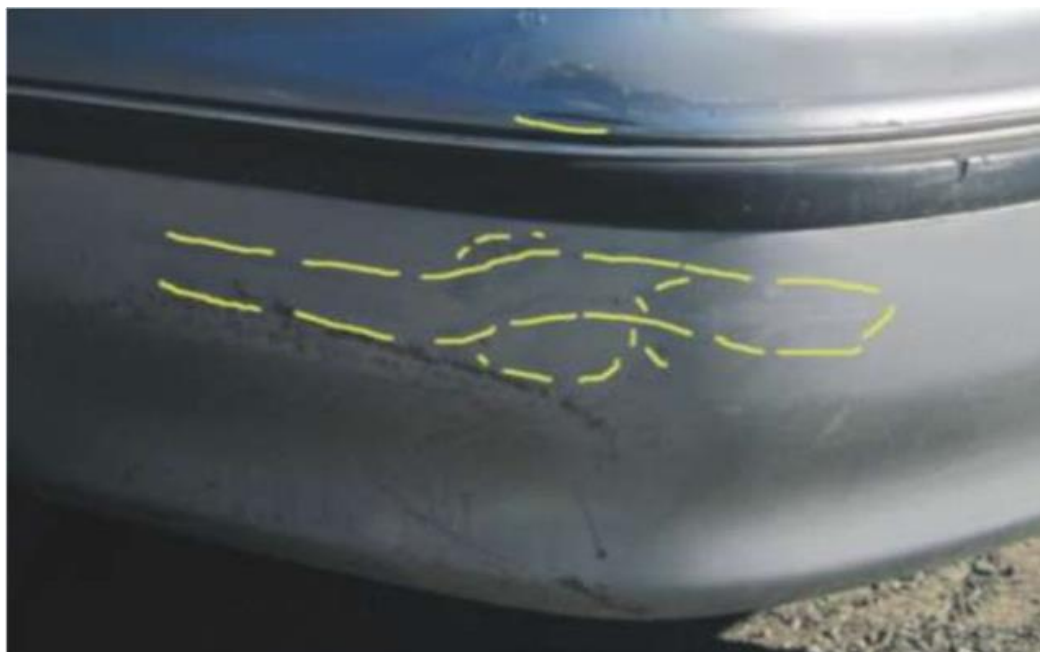
Rear-left view of the abrasion on the rear bumper

Fig.7 display of Honda Accord bumper damage

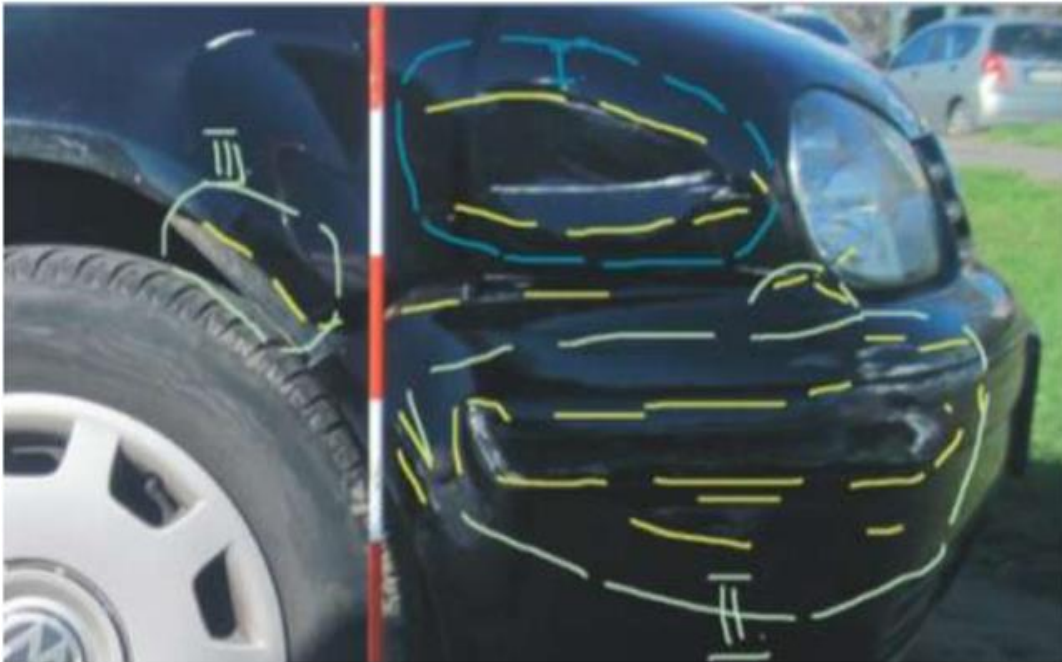
Front right side Section I – pressed, Section II – abrasion, Section III – deformation Fig.8, Fig.9

Fig.8 display of VW Golf bumper damage

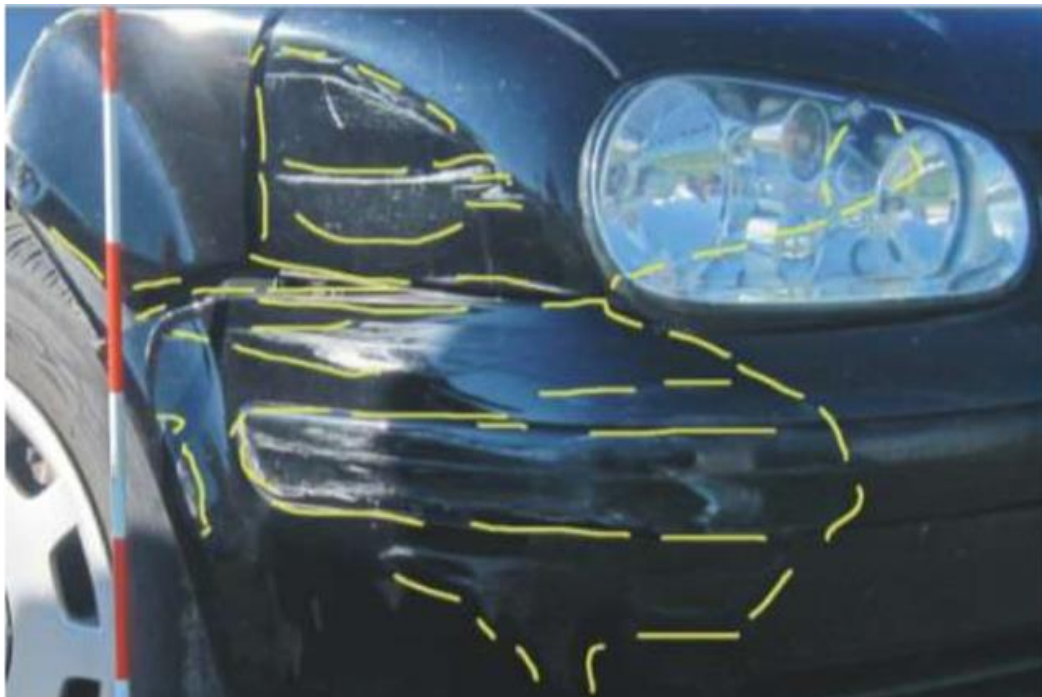
Front-left view of the damaged zones:

Fig.9 display of VW Golf bumper damage

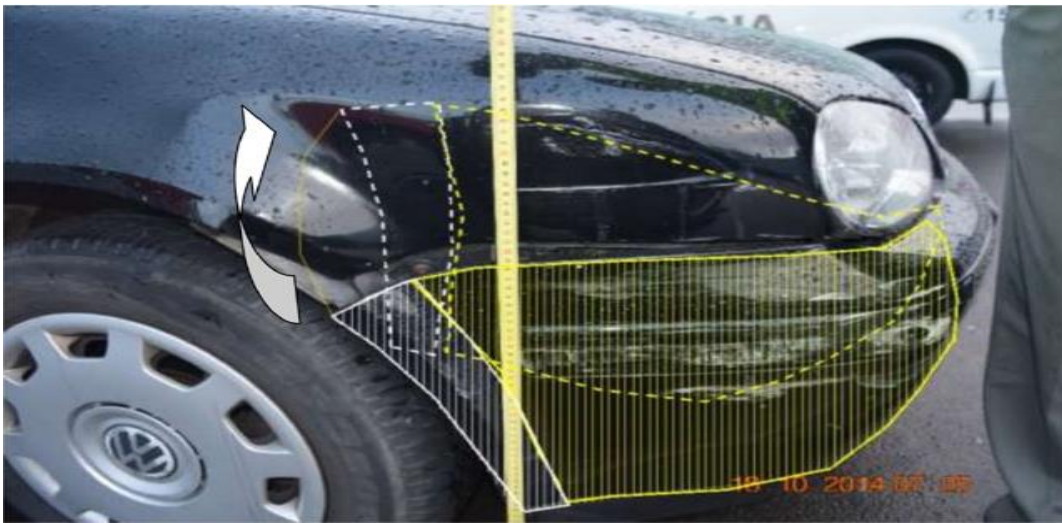
Description of the damage occurrence: Provided the Honda had been accelerating at the moment of the first contact, and if, subsequently, it had been braking, we cannot rule out that due to the contact with the front part of the right bumper of the Golf the right bumper would have shifted and after that it would have pressed down towards the front part. As a result, the rear part of the right bumper got released and began to move upwards, capturing the edge of the front right fender, and deforming it; then rear part of the right bumper was pressed against the front right fender and caused deformations at the height of the headlight. Afterwards, when the pressure was released, the rear part of the right bumper began to move downwards and remained in its detected position. This would correspond with the twisted front part of the right bumper and the broken headlight, which was caused by the bumper movement upwards. We cannot rule out that as a result of the movement of a bumper there was a wide abrasion compared with a relatively narrow abrasion zone on the rear bumper of the Honda, which shows a certain extension behind the rounding that could have occurred as a result of the pressure of the right part of the front bumper.

Fig.10 The view of the VW Golf bumper changed position due to the collision caused by the Honda Accord

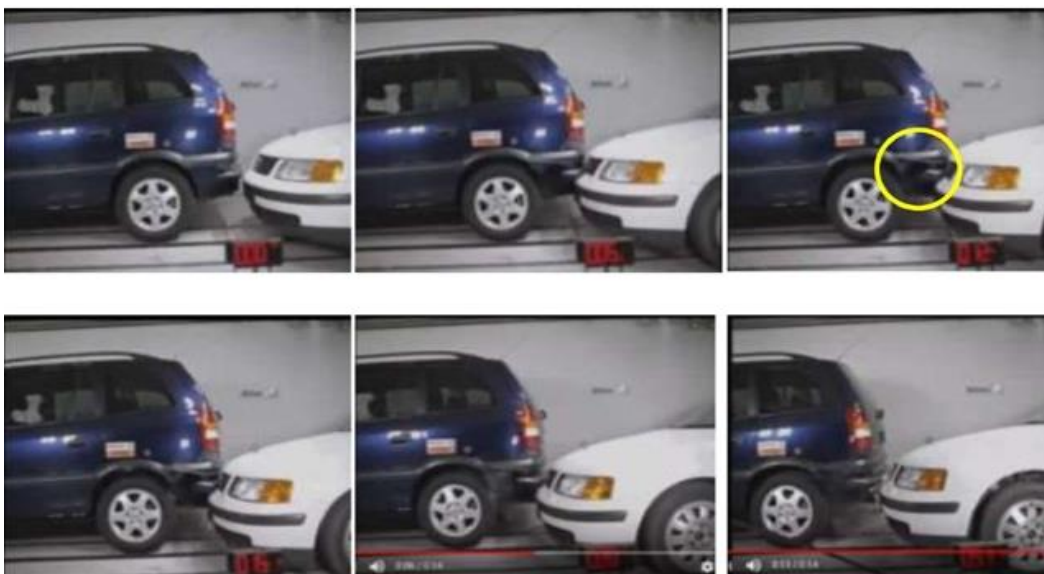
For this, a Crash test video has been searched for in the court, where a similar movement of the bumper is shown. The details shown below Fig 11.

Fig.11 View Crash Test Sequence with Bumper Movement

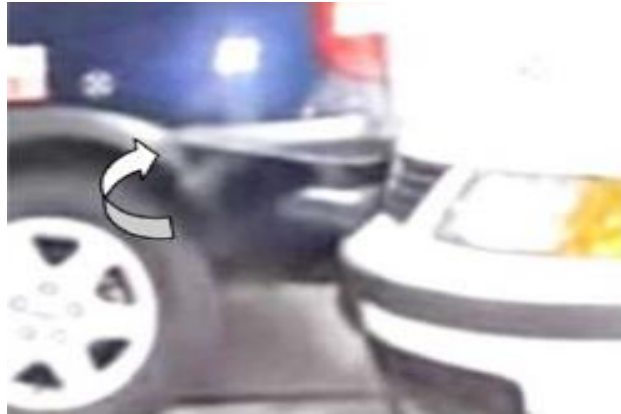
Fig.12 Detailed view of a bumper position after crash

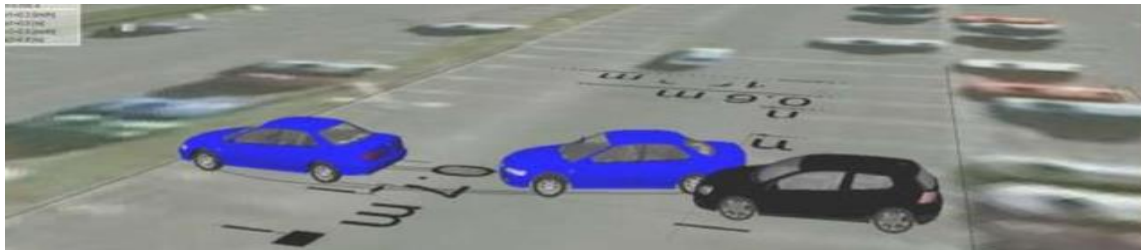
Further, the technical expert made calculations of the Honda Accord motion using the PC calculation program PC Crash – the following is the calculation display Fig. 13.

Fig. 13 Displays the initial and final position of the Honda Accord according to the calculation
